PLAY AREA SAFETY INSPECTION REPORT

For Walberswick Common Lands Charity/Walberswick PC

On 23rd March 2018

Play Area, Common, Church Lane, Walberswick

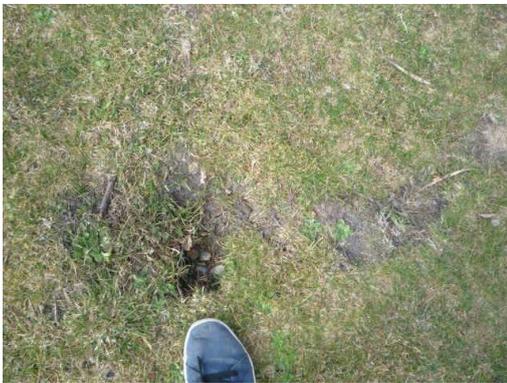
General surface –Grass –Recommend infill Rabbit holes, which are trip hazards (this should be an ongoing operation) –Low to Medium risk.

Commented [AL6]: Initial repairs completed – ongoing task now in place as part of play equipment monthly check

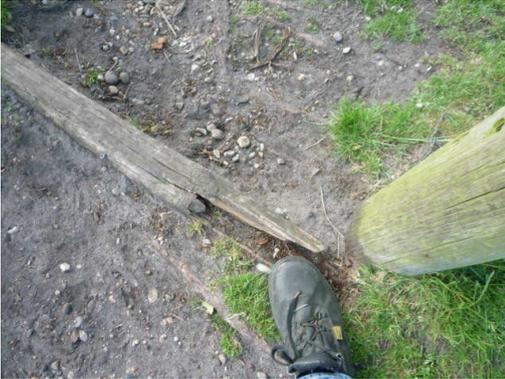
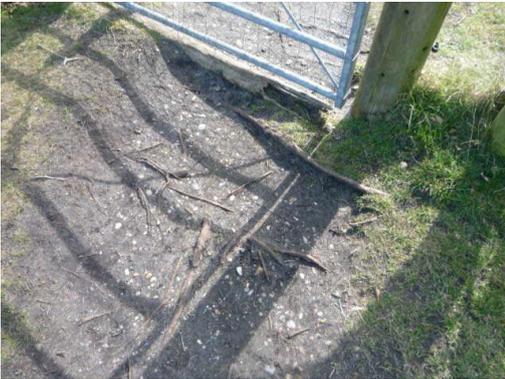
Access –Recommend removed damaged log under pedestrian gate, and remove /cover roots which are a trip hazard –Low to Medium risk.

Commented [AL7]: Completed

Commented [AL8]: Agreed. ACTION: Lee

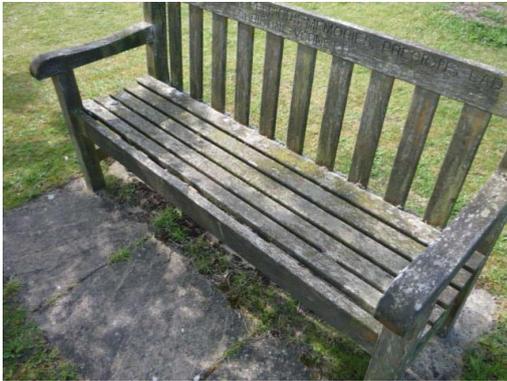
Seats x 3 –Timber preservation is in poor condition to one seat. Recommend Rub Down and Stain with appropriate preservative. Most preservatives sold as child friendly by major DIY chains meet these standards.

Commented [AL9]: Owners to be sought for remedial work – ACTION: Esme

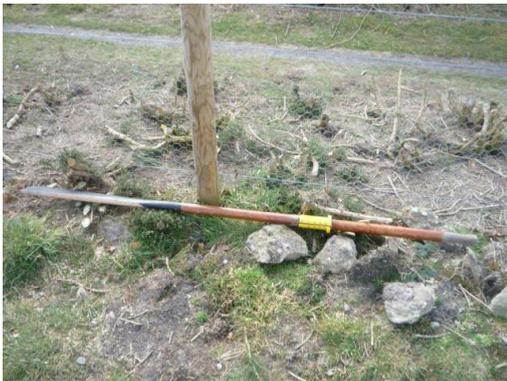
Recommend remove Oar from site, as it can be played with –Low risk.

Commented [AL10]: Completed

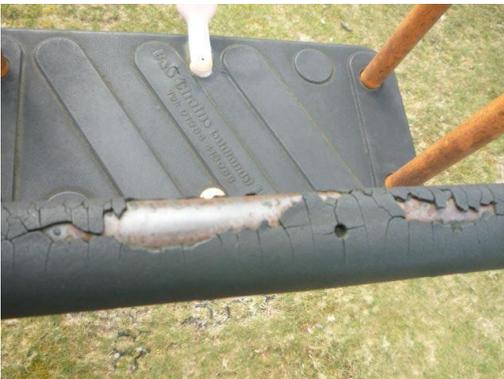
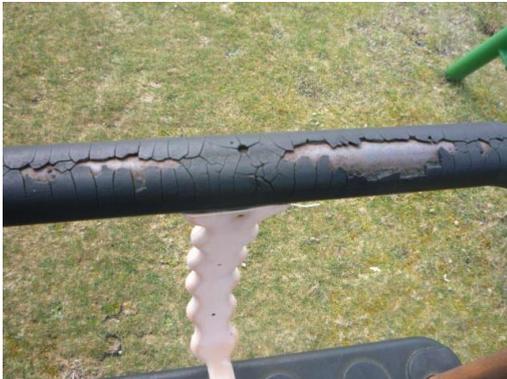
Recommend replace two seats with metal exposed –Low risk.

Commented [AL11]: Proposed to duct tape it for 2018 and replace in 2019 – ACTION: Lee

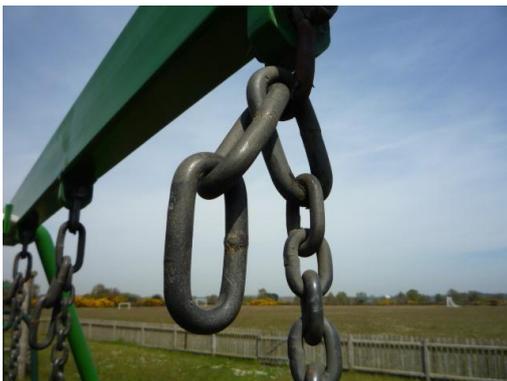
Recommend remove large unused chain links at top of suspensions – Low risk.

Commented [AL12]: No immediate action proposed

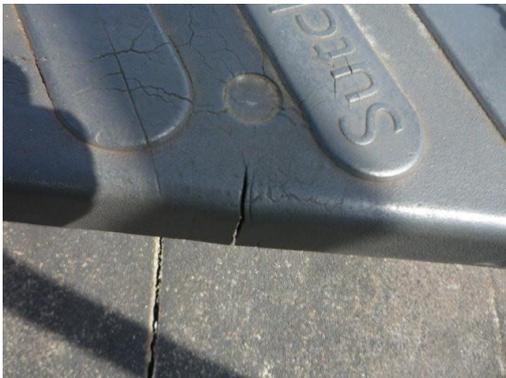
The swing seat has been damaged but does not require immediate replacement. Monitor and replace when hard material is exposed.

Commented [AL13]: No immediate action proposed

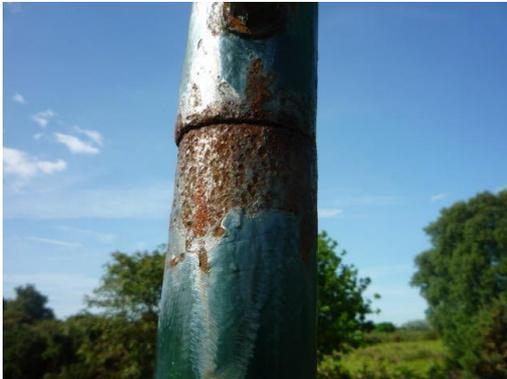
Paintwork is in poor condition. Recommend De-scale and coat with lead free paint, using appropriate precautions.

Commented [AL14]: Agreed via local tradesman.
ACTION: Esmé

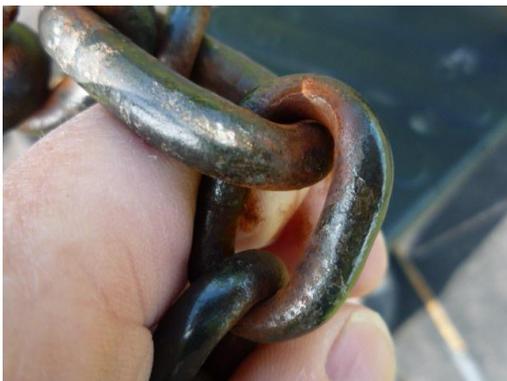
Some chain wear. Recommend Monitor for further deterioration and replace at 40% wear.

Commented [AL15]: No immediate action proposed

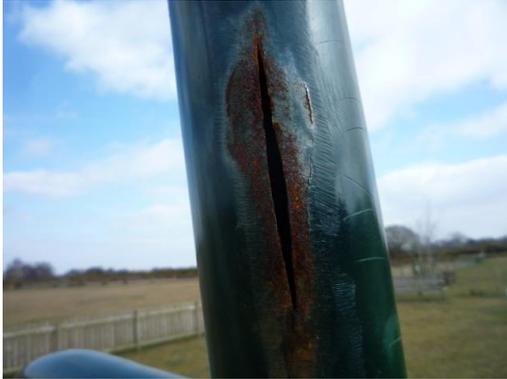
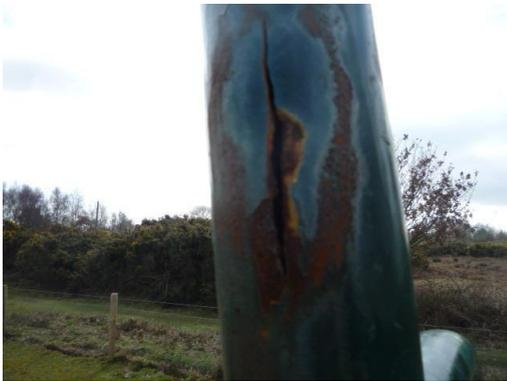
Recommend repair two supports that have splits –Low risk.

Commented [AL16]: Propose repair in 2019 – ACTION: Lee

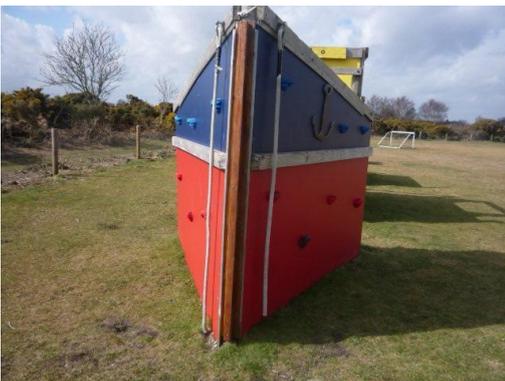
The item fails to meet the requirements of EN1176 in the following respects:

Recommend that the two climbing ropes should be secured (clamped) at each end, and should not be loose to make a loop, which could be an entrapment risk. When securing the ropes, it must be ensured that the space between rope and panel is greater than 230mm at one point to eliminate entrapment – Medium risk.

Commented [AL17]: Propose removal – ACTION: Lee

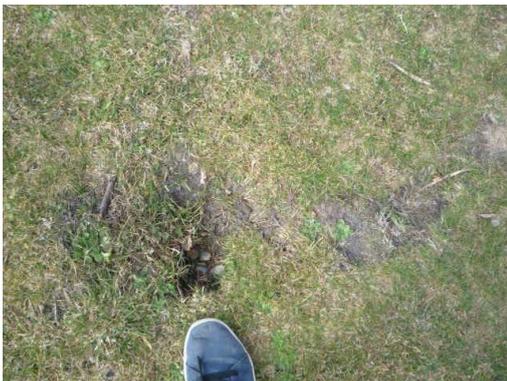
Recommend infill rabbit holes, which are trip hazards –Low to Medium risk.

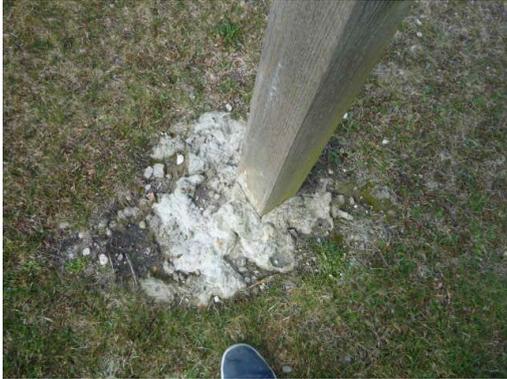
Recommend cover concrete at bottom of mast – Low risk.

Commented [AL18]: Some concrete to be removed –
ACTION: Lee

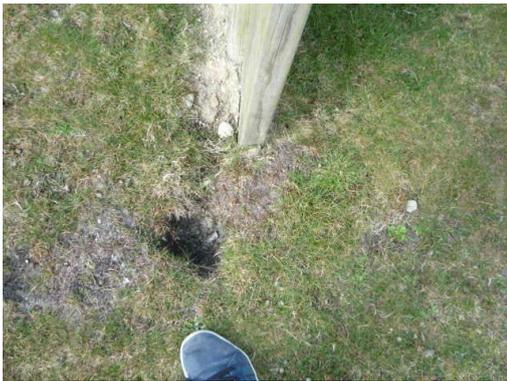
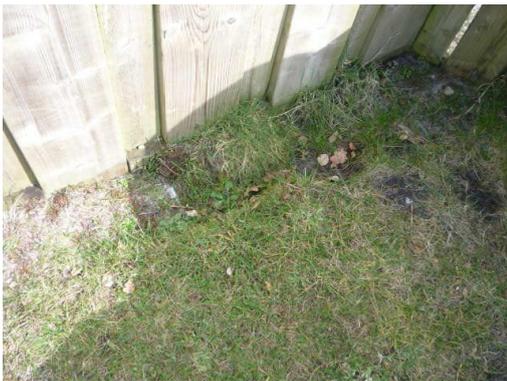
Recommend infill rabbit holes, which are trip hazards –Low to Medium risk.

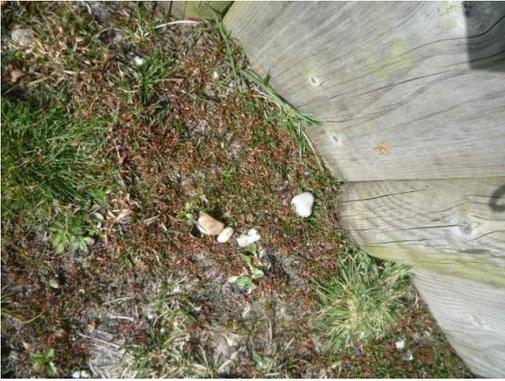
Recommend remove loose stones –Low risk.

Commented [AL19]: No immediate action proposed

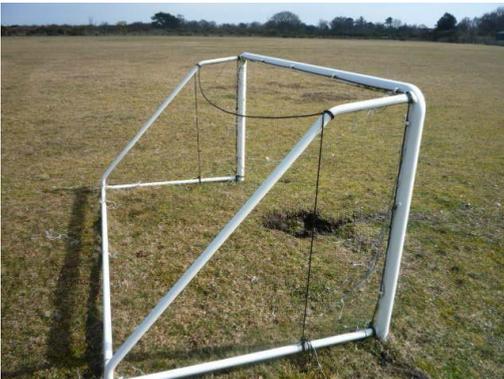
Recommend replace one missing net –Low risk.

Commented [AL20]: Agreed: ACTION: Lee

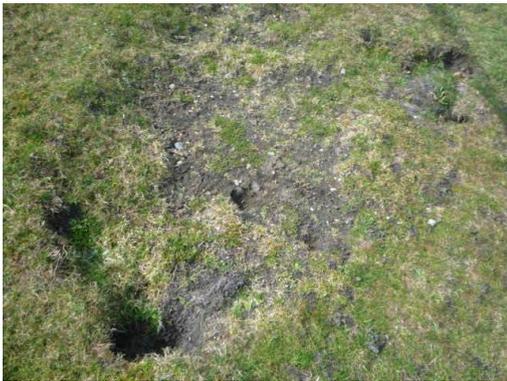
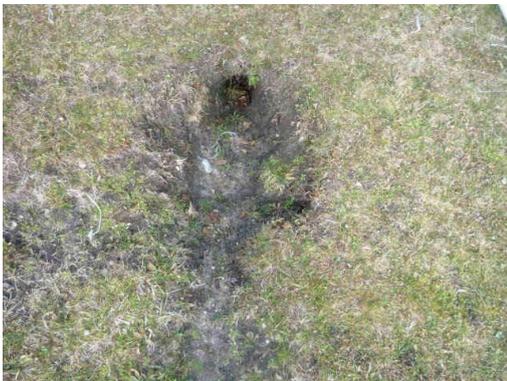
Recommend infill rabbit scrapes and make good worn areas with turf –
Medium risk.

Commented [AL21]: Initial phase completed and now on monthly inspection

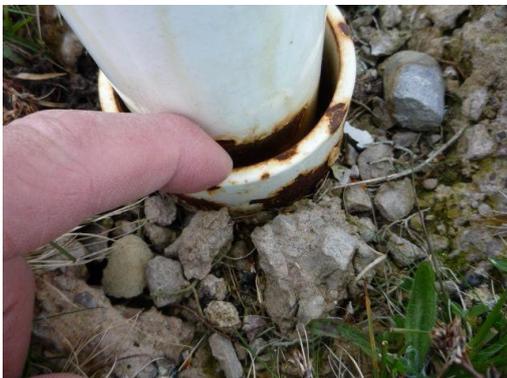
Full size goals fail to conform to BSEN 748 in the following:

Finger entrapments in sockets x 4 –Recommend add wedges to eliminate entrapments.

Commented [AL22]: Agreed: ACTION: Lee

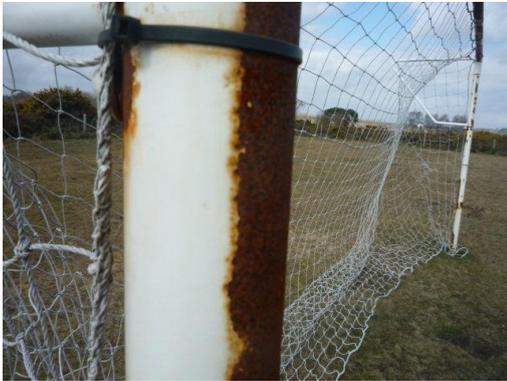
Paintwork is in poor condition. Recommend De-scale and coat with lead free paint, using appropriate precautions.

Commented [AL23]: Agreed via local tradesman
ACTION: Esme

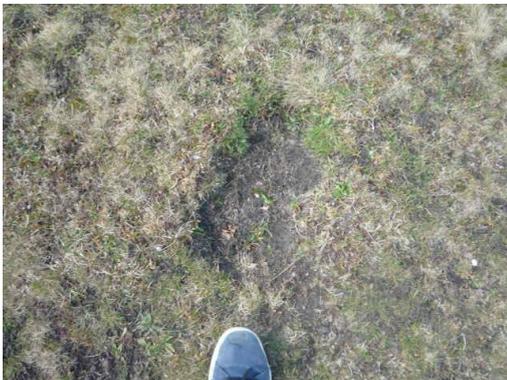
Recommend infill rabbit scrapes to eliminate trip hazards =Low to Medium risk.

Commented [AL24]: Initial work done – now on monthly inspection

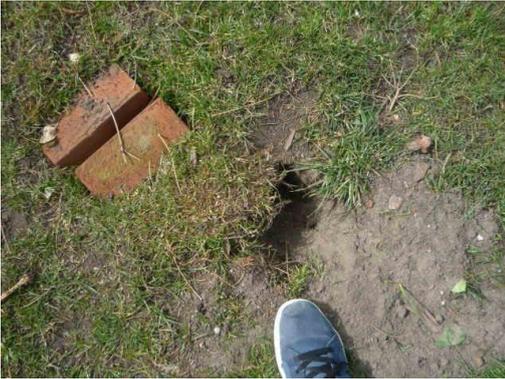
General surface – Grass –Recommend infill rabbit holes to eliminate trip hazards (ongoing) –Low to Medium risk.

Commented [AL30]: Initial actions completed and now part of monthly monitoring

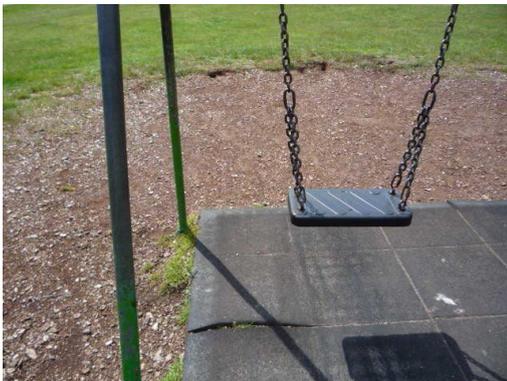
The distance between the seat side and the support is insufficient – Recommend Monitor – Low Risk.

Commented [AL31]: no immediate action proposed

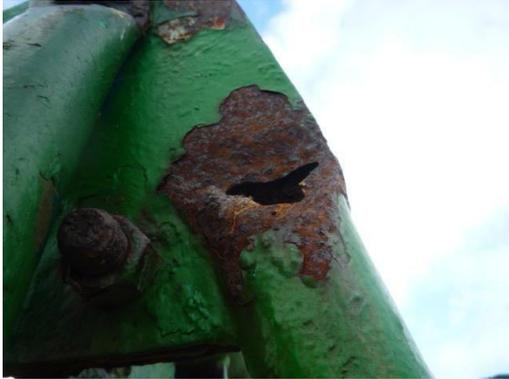
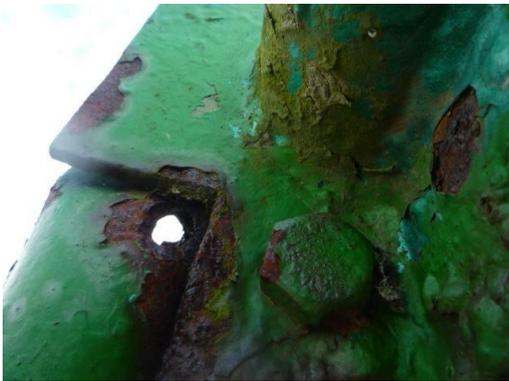
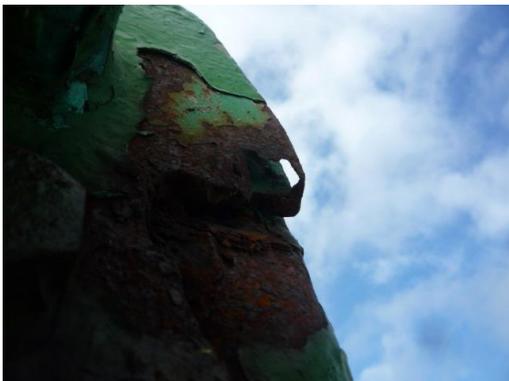
Recommend infill holes at top of support, remove rust and repaint entire item, further repairs may be required/revealed when rust has been removed – Medium risk.

Commented [AL32]: Agreed and mobile welder needed. ACTION: Lee & Esme

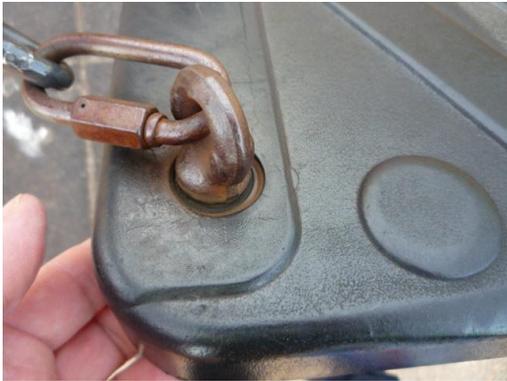
Recommend tighten loose seat bolts x 4 –Low risk.

Commented [AL33]: Agreed. ACTION: Lee

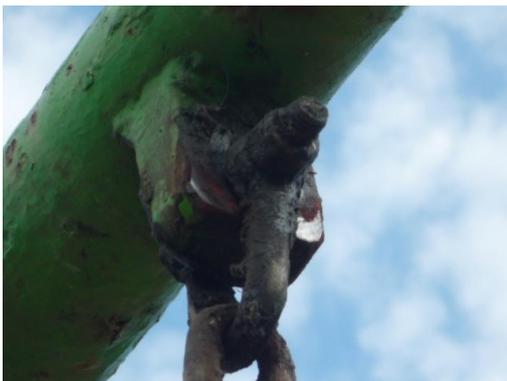
Recommend to remove shackle bolt and check bush and shackle pin wear, replacing if necessary.

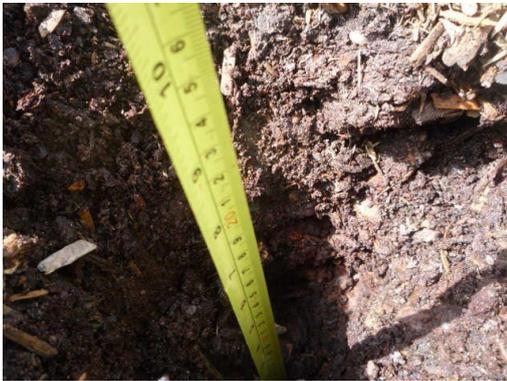
Loose fill levels are too low to provide adequate protection. Recommend fork over and top up (with Bark that complies with EN1176 recommendations) as required to maintain minimum depth (usually 300mm) – currently 240mm –Low risk.

Commented [AL34]: Initial work completed and now part of monthly inspection

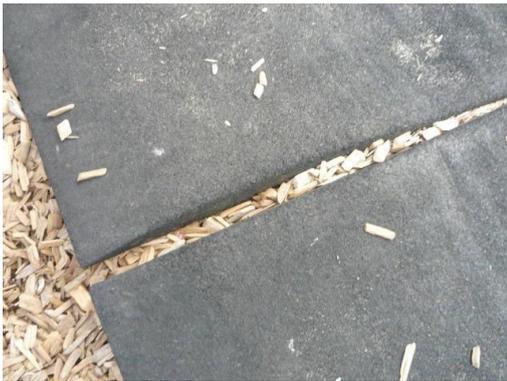
Surface is lifting. Recommend rearrange, re-glue and fill gaps and joints as necessary - Low risk.

Commented [AL35]: no action proposed until resurfacing is completed

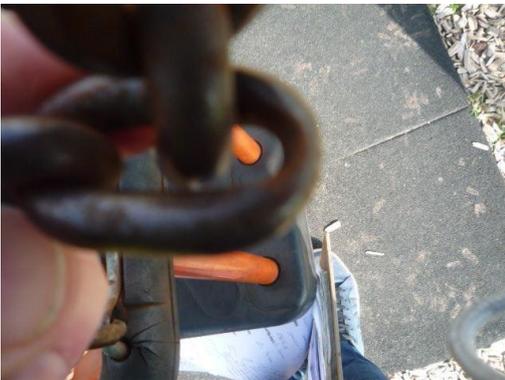
Chains worn, recommend monitor and replace when 40% worn –Low risk.

Commented [AL36]: Now part of monthly inspection

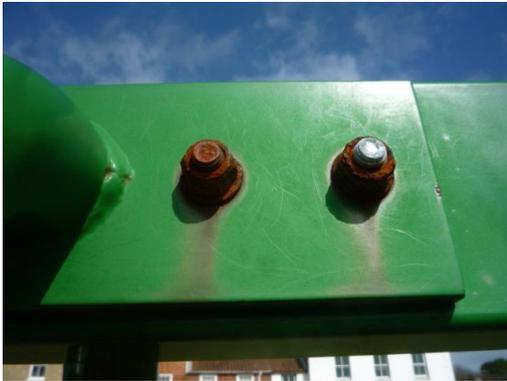
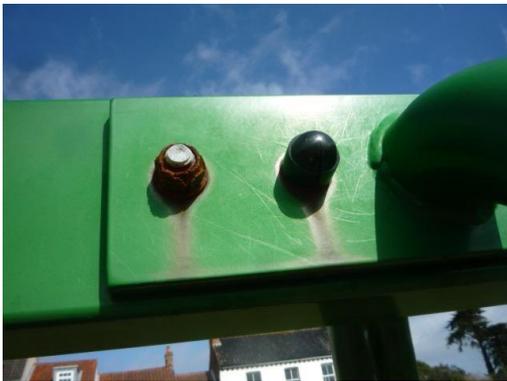
Recommend replace missing caps x 3 –Low risk.

Commented [AL37]: Agreed. ACTION: Lee

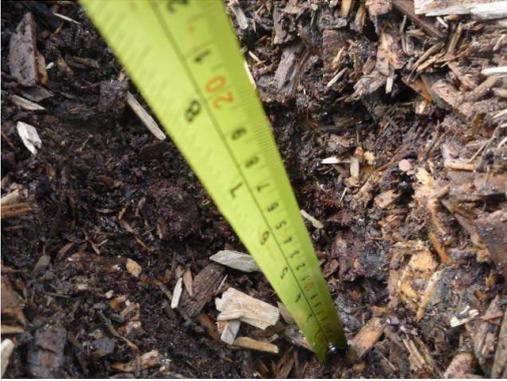
Loose fill levels are too low to provide adequate protection. Recommend fork over and top up (with Bark that complies with EN1176 recommendations) as required to maintain minimum depth (usually 300mm) - currently 200mm - Low risk.

Commented [AL38]: no action proposed until resurfacing completed

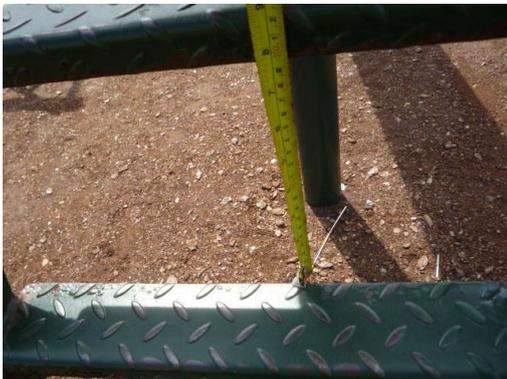
Access fails entrapment requirements (at steps) - Recommend monitor only – Low Risk.

Commented [AL39]: Now part of monthly inspection

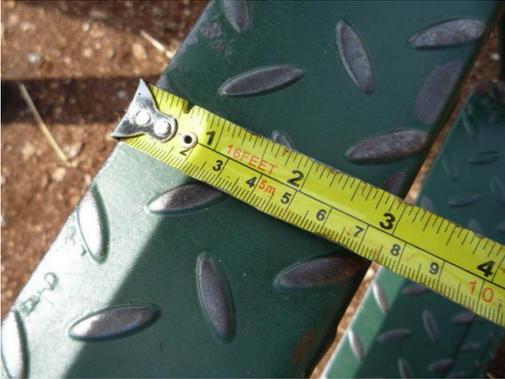
Width of steps fail EN1176 – Recommend monitor only –Low risk.

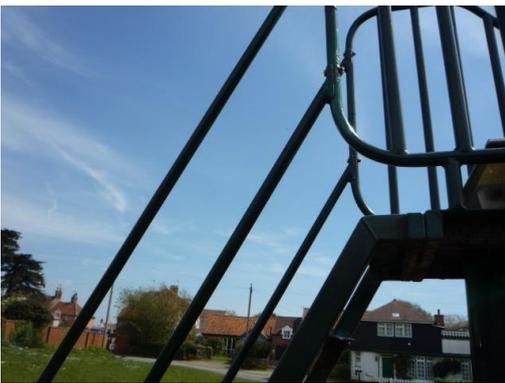
Steps should have infilled barriers –Recommend monitor only – Low risk.

Commented [AL40]: Now part of monthly inspection

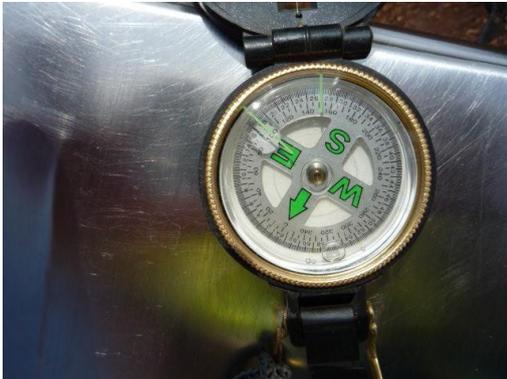
NB Although not part of EN1176 – the slide surface faces south and may suffer from solar gain and get hot during the summer – Recommend monitor –Low risk.

Commented [AL41]: no immediate action proposed

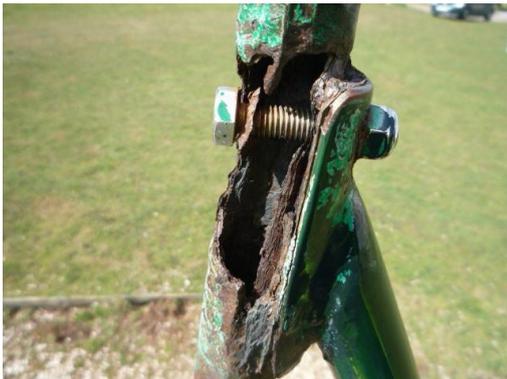
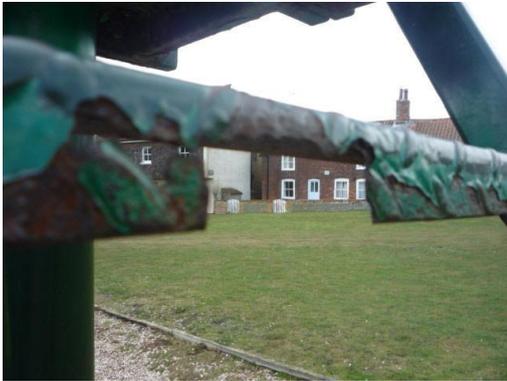
Recommend repair/replace rotten sections at slide barrier and at step (sharp edges) –Medium risk.

Commented [AL42]: Agreed, but mobile welder needed. ACTION: Esme & Lee

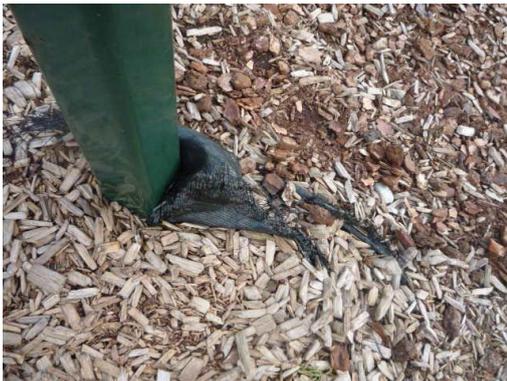
Loose fill levels are too low to provide adequate protection. Recommend fork over and top up (with Bark that complies with EN1176 recommendations) as required to maintain minimum depth (usually 300mm) – currently 170mm and geotextile is exposed – Low to Medium risk.

Commented [AL43]: no action proposed until resurfacing completed
