PLAY AREA SAFETY INSPECTION REPORT

For Walberswick Common Lands Charity/Walberswick PC

On 23rd March 2018

Play Area, Common, Church Lane, Walberswick

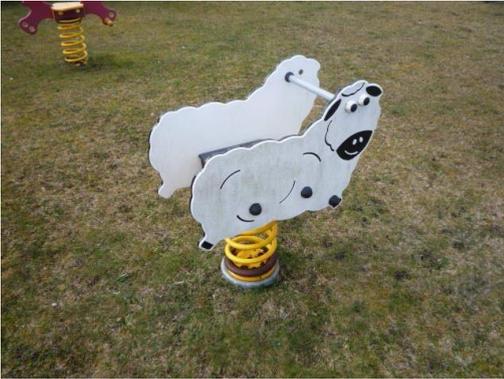
Item: Springy Sheep - Fahr

The item meets the requirements of EN1176 where this may be tested on site without dismantling or destruction.

The surfacing is in satisfactory condition and no work is required at this time.

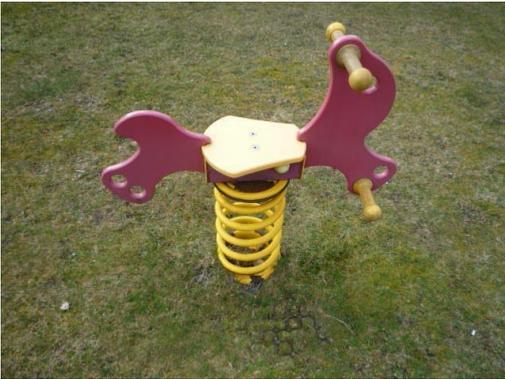
Item: Springy Racer - Playquip

The item meets the requirements of EN1176 where this may be tested on site without dismantling or destruction.

The surfacing is in satisfactory condition and no work is required at this time.

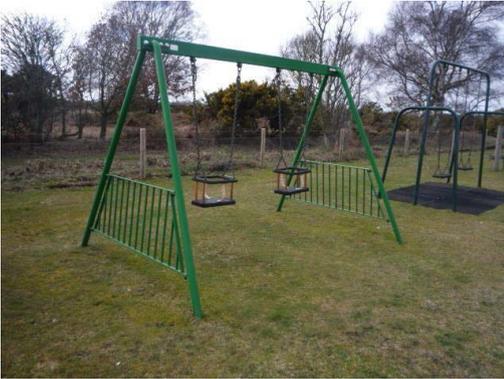
Item: 1 Bay 2 Cradle Seat Swing (2000mm) - Playquip

The item meets the requirements of EN1176 where this may be tested on site without dismantling or destruction.

The surfacing is in satisfactory condition and no work is required at this time.

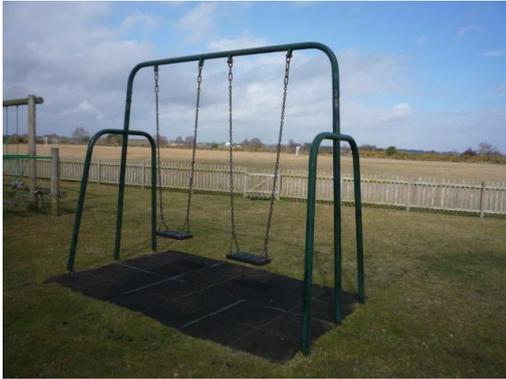
Item: 1 Bay 2 Flat Seat Swing (2400mm)– Sutcliffe Leisure

The item meets the requirements of EN1176 where this may be tested on site without dismantling or destruction.

The surfacing is in satisfactory condition and no work is required at this time.

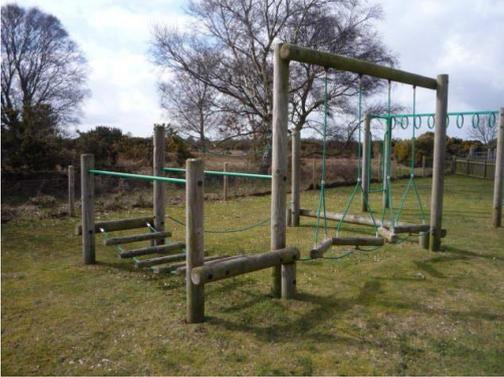
Adventure Cube – Evans

The item meets the requirements of EN1176 where this may be tested on site without dismantling or destruction.

The surfacing is in satisfactory condition and no work is required at this time.

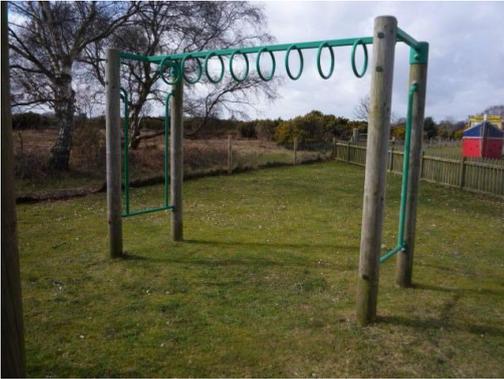
Item: Ring Ladder - Evans

The item meets the requirements of EN1176 where this may be tested on site without dismantling or destruction.

The surfacing is in satisfactory condition and no work is required at this time.

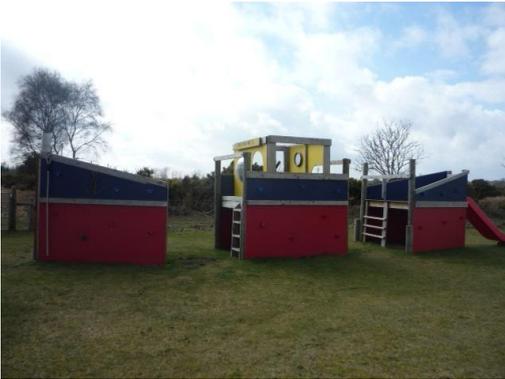
Large Boat – Marriot Play and Leisure

The item fails to meet the requirements of EN1176 in the following respects:

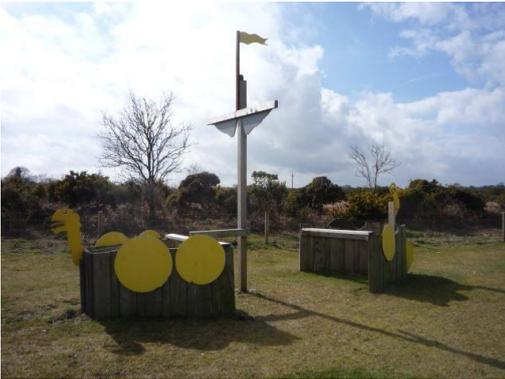
Small Boat – Marriot Play and Leisure

The item meets the requirements of EN1176 where this may be tested on site without dismantling or destruction.

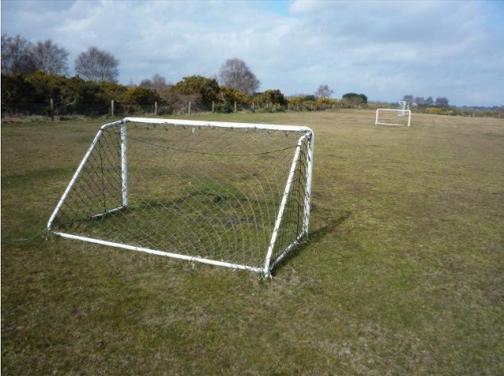
Small Goals

The item meets the requirements of BSEN 748 where this may be tested on site without dismantling or destruction.

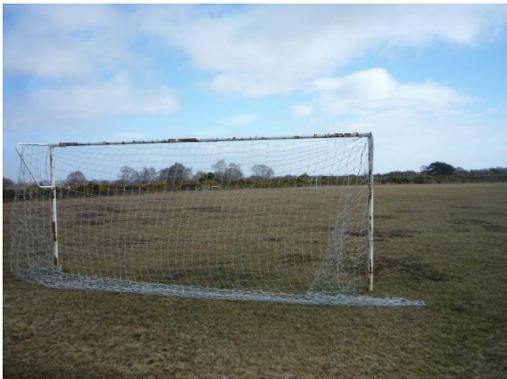
Item: Two Full Size Goals

Full size goals fail to conform to BSEN 748 in the following:

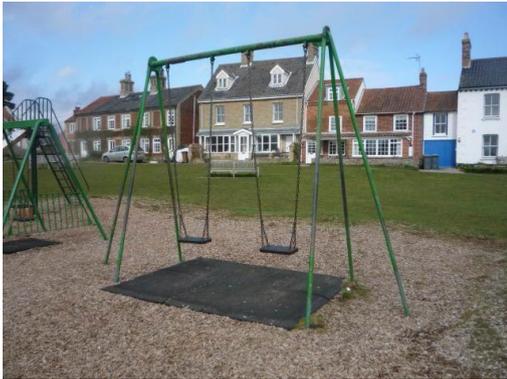
Item: 1 Bay 2 Flat Seat Swing (2700mm)

The distance between the seat side and the support is insufficient – Recommend Monitor – Low Risk.

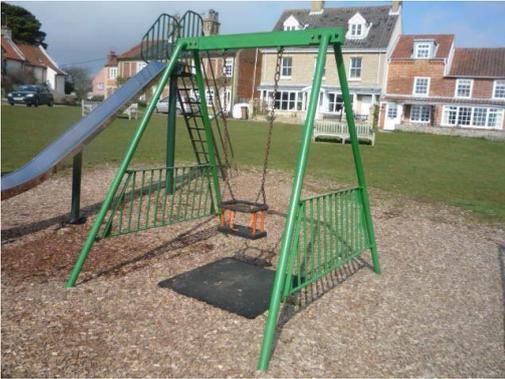
Item: 1 Bay 1 Cradle Seat Swing (2000mm) - Playquip

The item meets the requirements of EN1176 where this may be tested on site without dismantling or destruction.

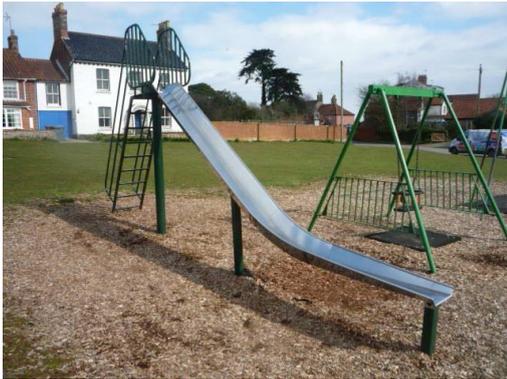
Item: Slide (2000mm) – Wicksteed Leisure

The item fails to meet the requirements of EN1176 in the following respects:
